Lagoon Balustrade Preliminary Assessment

Repair Process
West Balustrade
Sunken Garden
Summer 2003

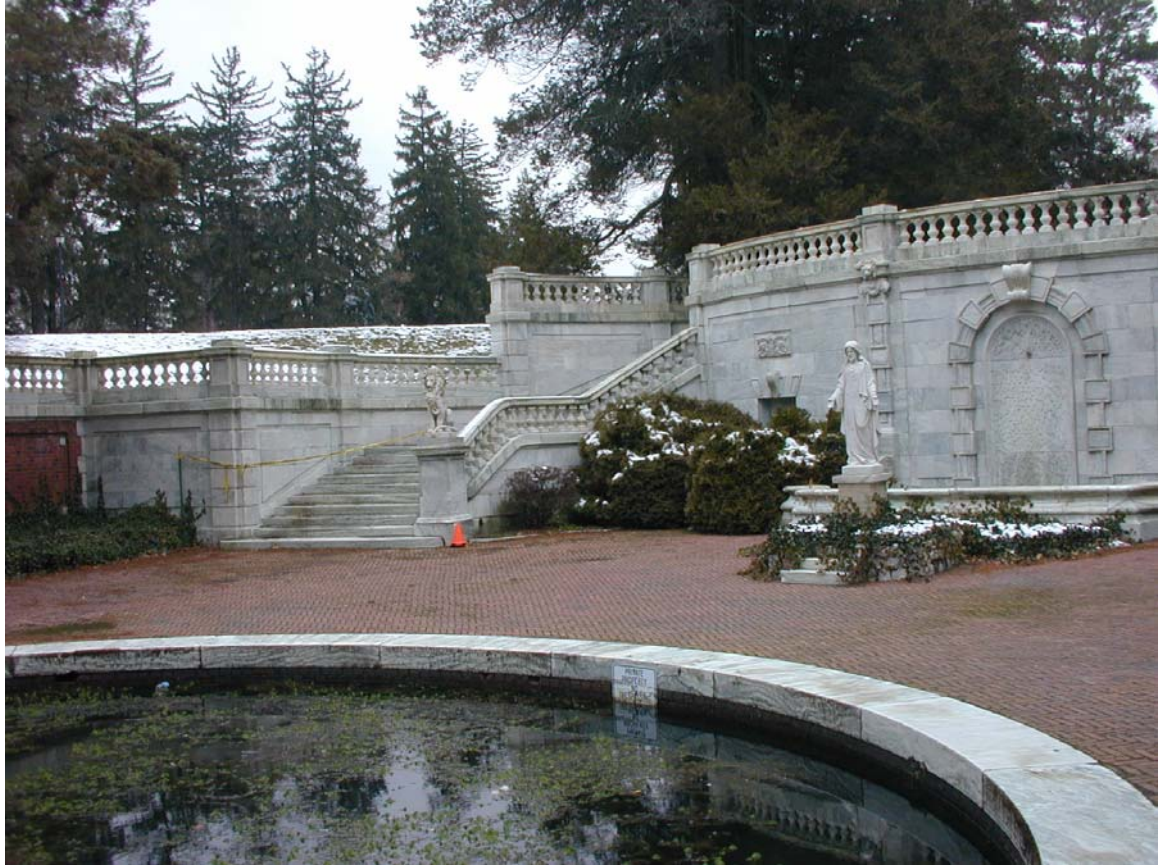
In the left rear of the photograph above, cordoned off with yellow caution tape, is the West Staircase of the Sunken Lagoon.

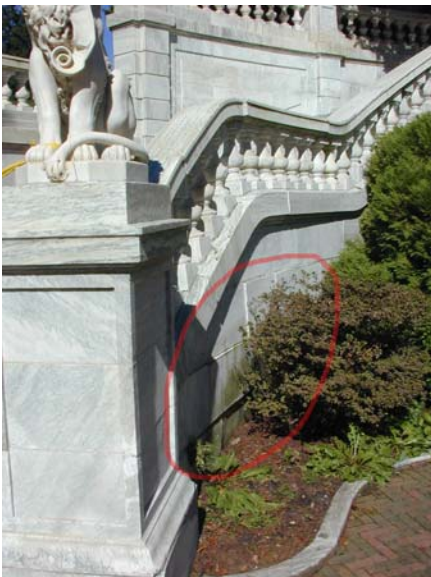
A shifting of the blocks outlined in red, to the left, has caused a pronounced list in the balustrade, shown at right. This list has reached a degree where it was determined a hazard to public safety, and the staircase closed to traffic.

Repairs in this case will likely require disassembly of the balustrade, and the inside retaining wall, before reaching a point where the cause of damage becomes evident, can be alleviated, and reassembly accomplished. It is possible that some below grade work will also be necessary.

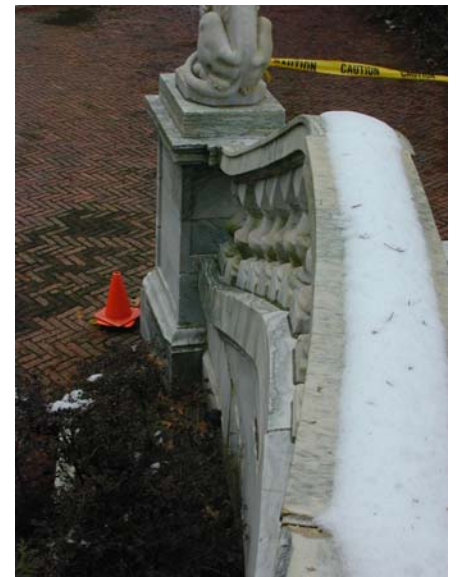
The width of the caulk joint between the risers and the lower rail of the balustrade is further evidence of this movement.

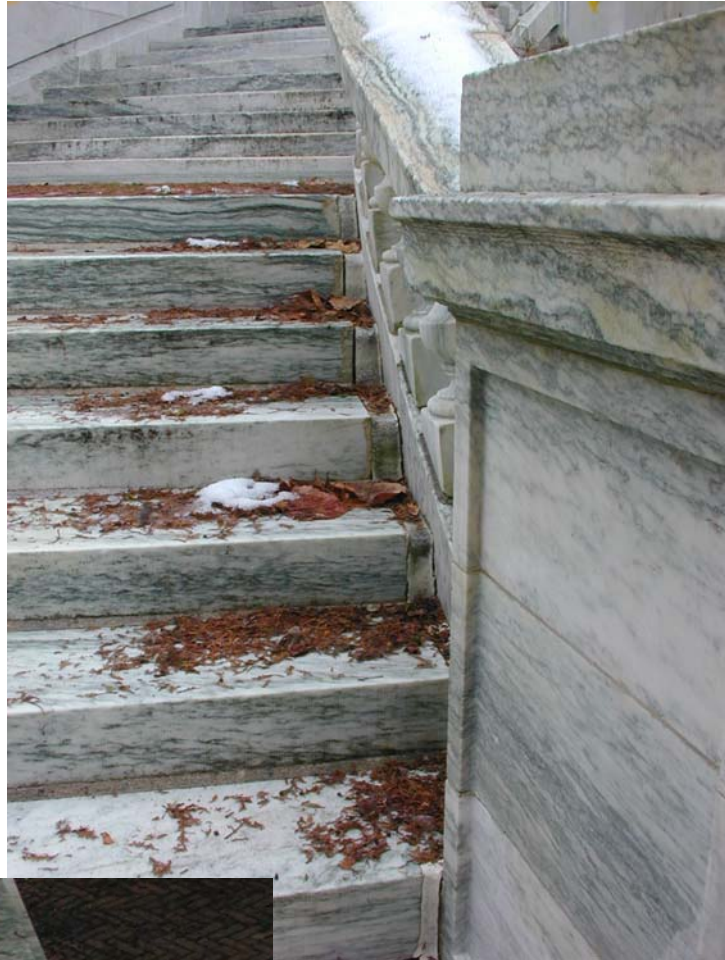
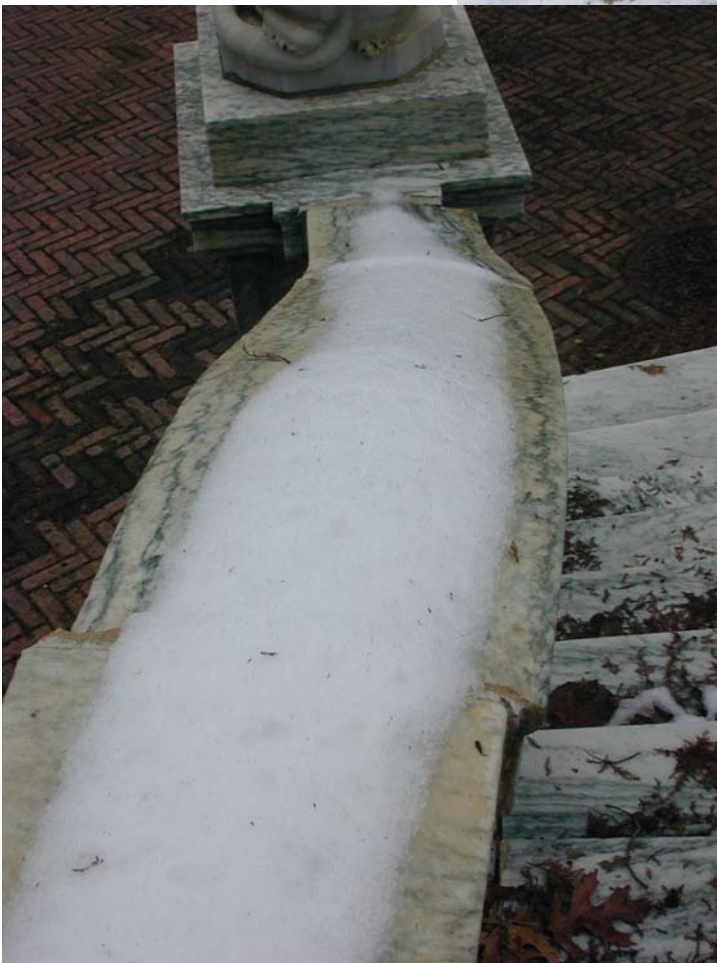
The displacement of the upper rail is clearly illustrated in the photo, at left.

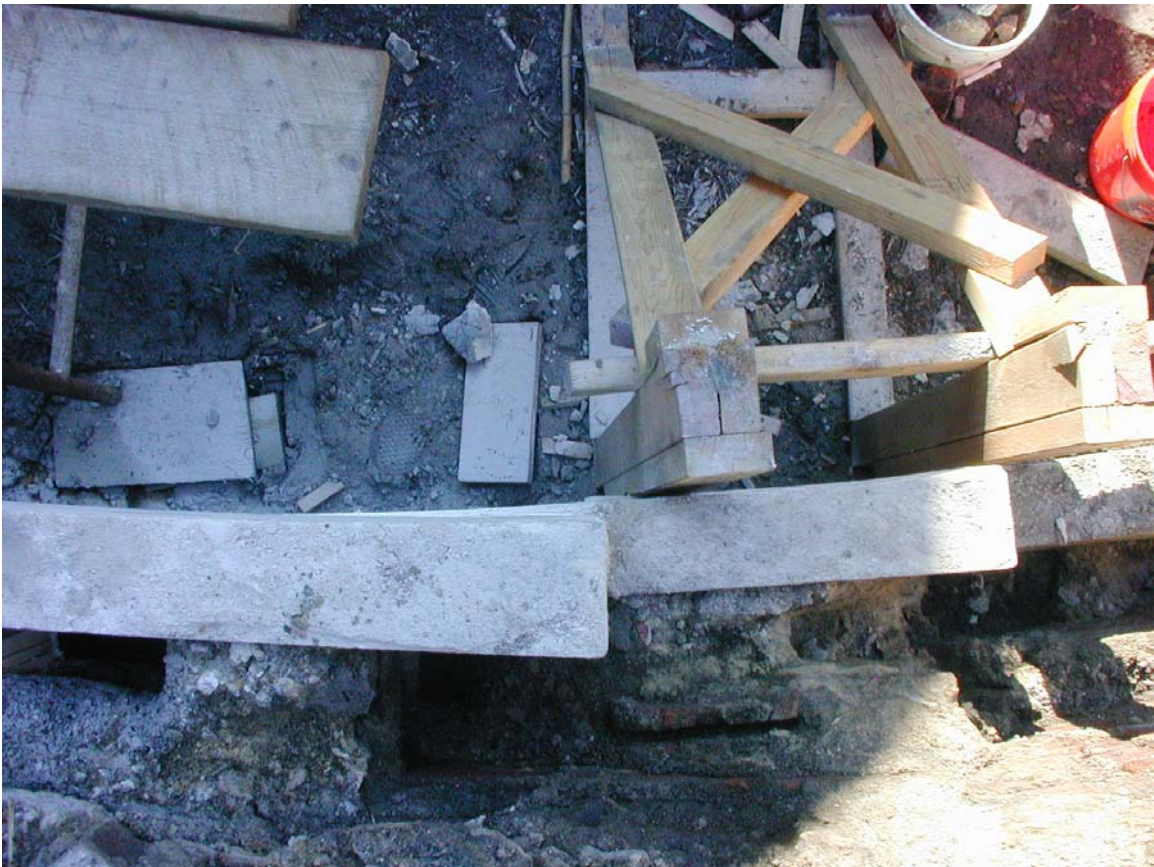
There is a considerable void between the masonry core and the marble façade. This void was filled with what appears to be soil that might have washed in through the opened joints between the treads and the wall cap. Confusing the issue is the presence of brick rubble in this fill. Did these bits flake off the face of the masonry mass as the sediments were deposited? Or, did the masons, hoping to provide additional support for the coping, fill with this organically rich material that by its nature holds moisture and would present difficulties generated by freeze/thaw action? As completed, the reconstruction was accomplished with the void unfilled and weeps at the base for drainage and aeration.

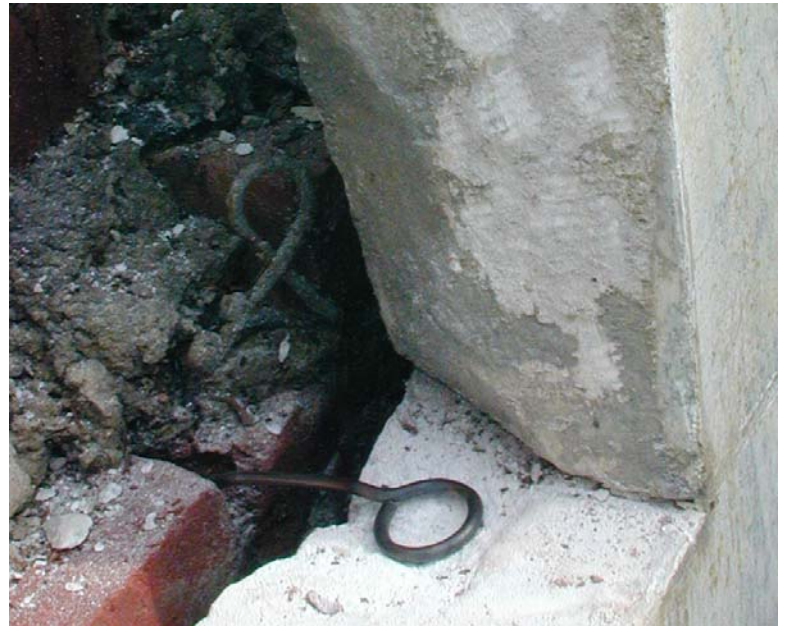
In the photo at right the never utilized tie is seen, in the background, bent up out of place. In the foreground is a new stainless tie, set and ready for the next stone

Nearly every stone has a depression carved to accept insertion of wire ties that should bind the façade to the core. All but one had been filled with mortar without use of the intended tie. The one installed tie was found at the junction where the vertical edge of stone 4D intersects the mid-point of stone 3E. It is from this point towards the bottom of the staircase where the major displacements had taken place. One other tie was found inserted into the masonry core, but it had never been set, in the marble. These ties were of galvanized steel and the one installed had corroded to the point that it broke off during the process of cleaning fill from the void between the core and façade. Stainless ties were fabricated for installation during re-construction.

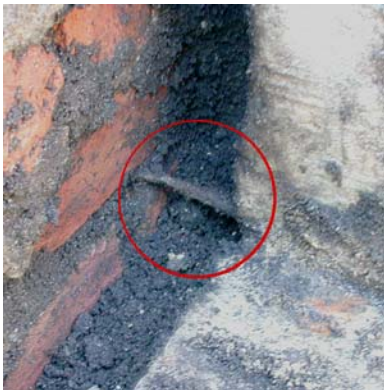
Circled, in the photo, at left, the one installed original wall tie.

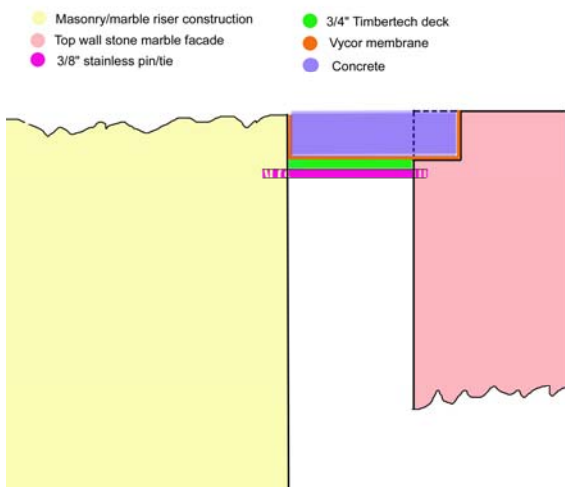
At this point we make our only major departure from the original design. As stated earlier, when dismantling the structure we discovered a cavity filled with soil and masonry debris. The copingstones are considerably wider than the façade blocks and in most places had less than a 50% bearing on the lower construction. It is very possible that the original masons purposely added this fill hoping to support the coping while the mortars set. If so the concept worked, initially. However, such a fill would hold moisture and in a freeze would exert an expansive force sufficient to displace the façade blocks. A slight movement would open the joints between the façade and the risers. In a thaw, the fill would soften and settle into the additional space left by the movement during freeze/expansion. Later rains would wash additional sediments into the open joints caused by the initial movement, beginning a cycle that could very likely have caused the eventual condition of near collapse. The fact that almost none of the intended anchors were installed certainly contributed to this progression. In order to cope with the situation, the following innovation was incorporated into the structure.

Hoping to keep the cavity open, facilitating drainage and aeration, it was decided to span the void between the top façade stone and the riser core structure with a concrete deck. Distributing the burden of the upper structures evenly amongst the separate lower constructs, provided a sound base for the copingstones without creating stresses that would encourage lateral movement. At left find the final detail for the concept.

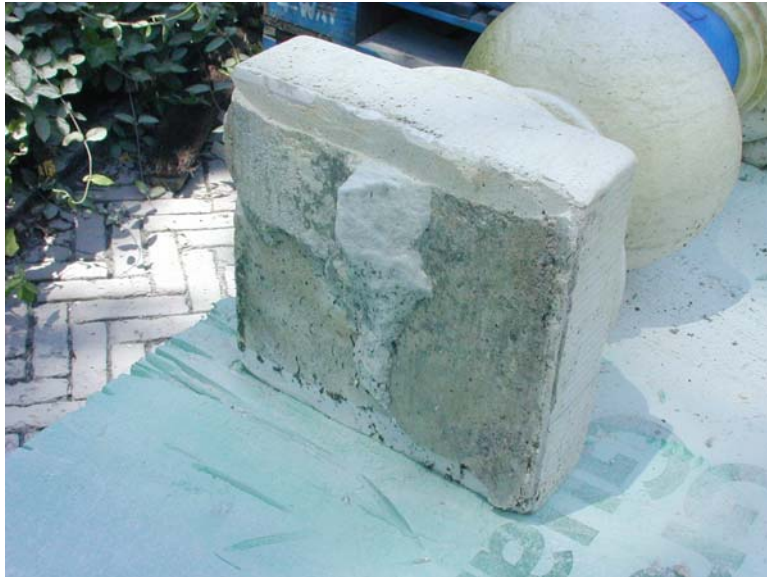
With setting of the copingstones the base structure was complete and we moved on to preparation of the balusters and rail. As can be seen at right, the material used to set the balusters was of an extremely tenacious bond. So much so that in dismantling, often the marble gave before the mortar. Before reassembly, the bonding surface of the stones had to be cleansed

In order to protect the vulnerable edges of the stone the old mortar was cut back using a four-inch diamond blade in a hand held grinder. Scoring of the mortar into a grid pattern allowed use of hammer and chisel to clear the bulk of the offensive material.

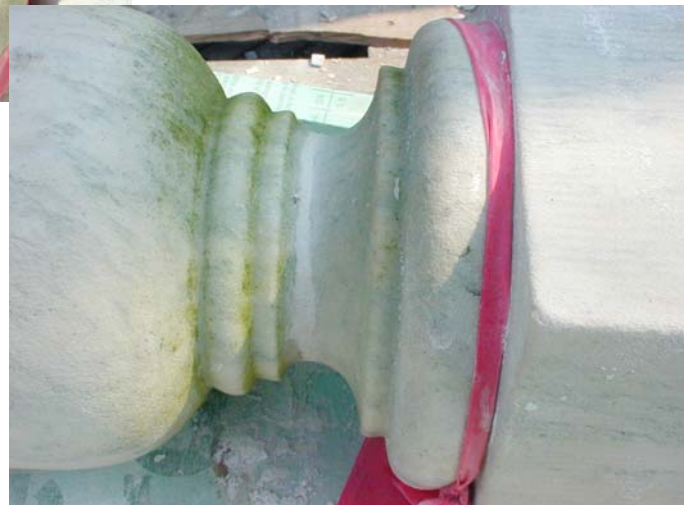
The photo at right shows the condition of the #1 baluster as we approached the job. Broken sometime in the past, the shards are unavailable, and replacements must be fabricated.

As documented in the previous operation, the stones are marked and drilled to accept stainless pins, that are anchored in Hilti epoxy, and left to cure overnight.

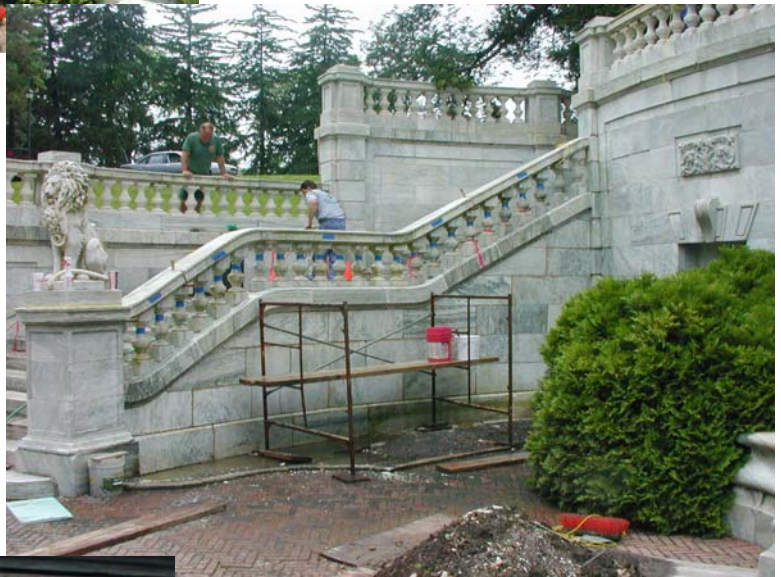
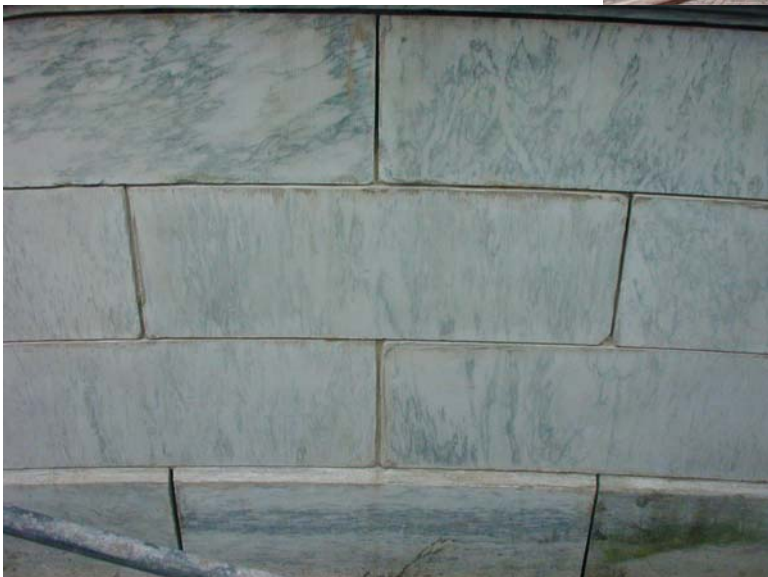
As mentioned earlier, previous repointing attempts had left a residue of hard Portland mortar, following the joints, and smeared across the face of the blocks. Because of the grooved texture applied as a finish to the stone neither hammer/chisel, nor grinder/sanders could be used to remove the material. As noted, a Dremel with shaped, heatless, ceramic wheels was used to carve away these unsightly deposits.
