Lagoon Balustrade Preliminary Assessment

Repair Process
West Balustrade
Sunken Garden
Summer 2003

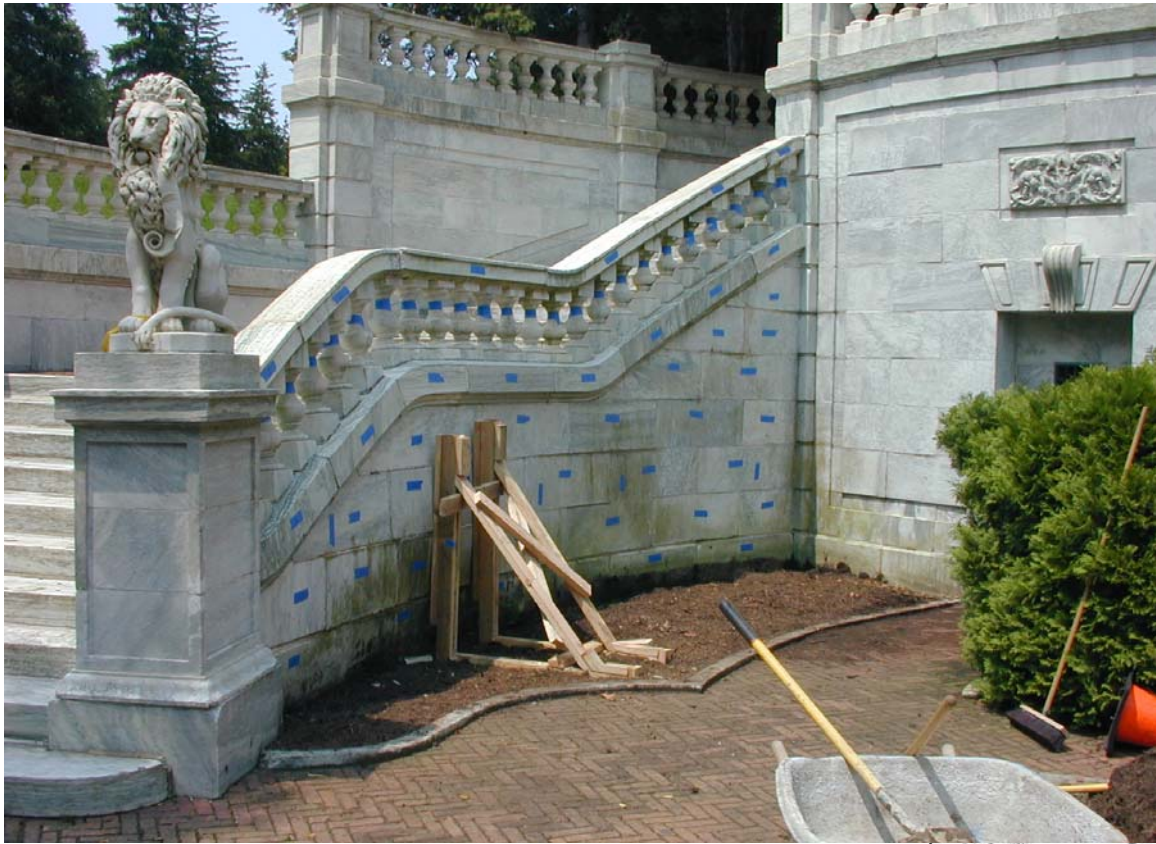
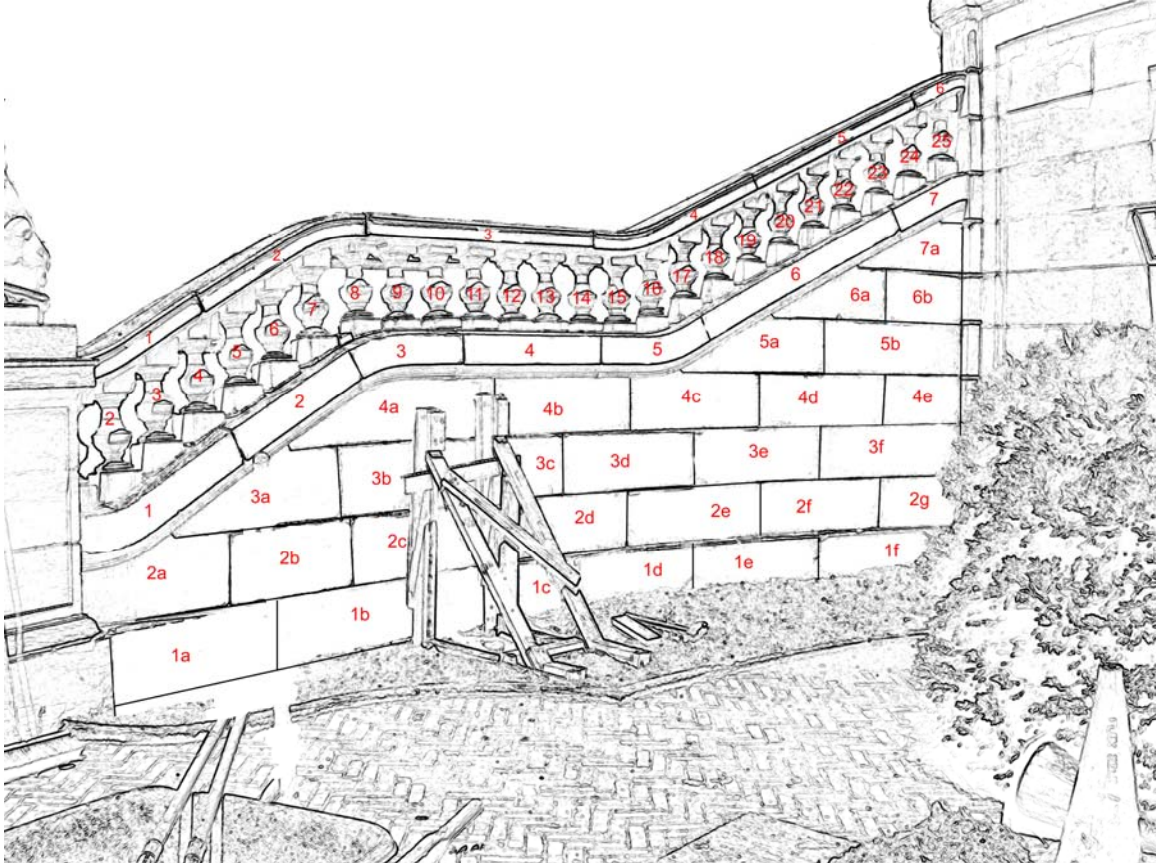
The first steps in the repair process entail the marking of each piece in the installation and mapping of its placement. The most severely buckled section of wall has been shored to protect against the danger of collapse as the upper sections are dismantled.

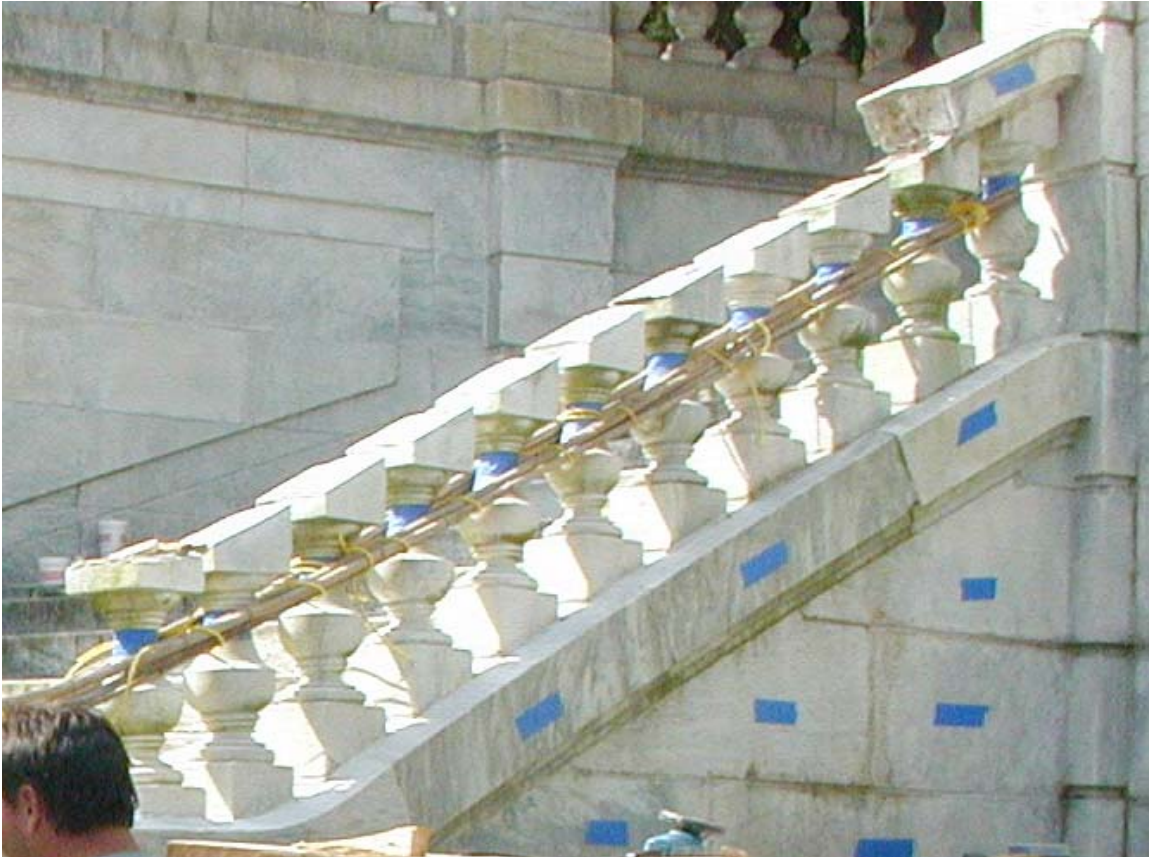
In order to separate individual stones from surrounding material, the mortar joints were cut with a four inch diamond blade in a hand held grinder, and hammer/chisel work. Wooden wedges were then driven into the spaces available, breaking the mortar bond, without damaging the visible edges. Elements were then lashed in rope slings, lifted by crane, and deposited on pallets. Fearing that the balusters might come loose and fall while lifting pieces of the top railing it was determined that they should be lashed together. Since the wall is curved, regular lumber could not easily be made to conform. Bundles of flexible bamboo were bent to shape and lashed together, inside and out. Once the top stones were removed, the lashings were undone, from the bottom up, and the

balusters removed one at a time. Several balusters evidenced cracks between the base and the central bulbous form. Only one could not be excised intact. This one had to be drilled and pinned before reinstallation.

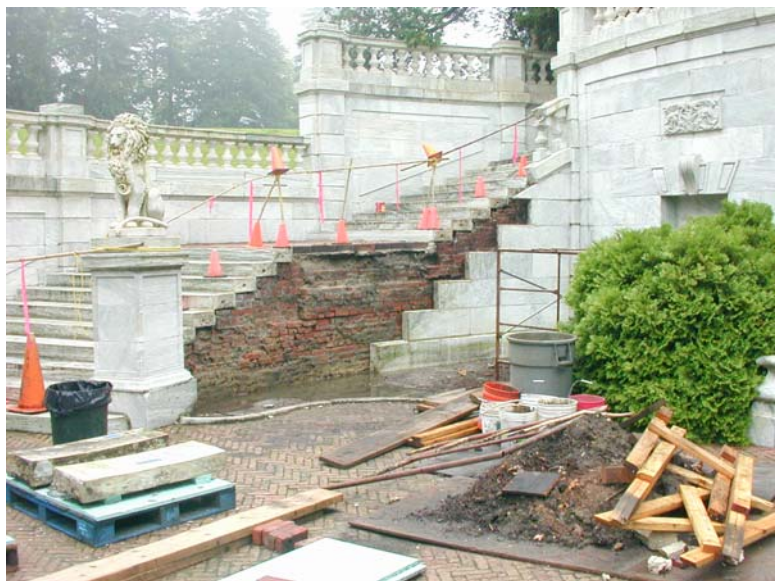
Fortunately, displacement of the wall did not extend beyond those stones locked in place by elements of the main façade. With stones removed, as shown to the right, all sediments and debris removed from the cavity between core and façade, we moved on to preparation for reinstallation.

Before resetting each stone had to be cleansed of old mortars still adhering to the bond surfaces, and, as much as possible, mortars bonded to the face. As noted earlier, the bedding mortars had deteriorated to the point where a stiff brush was sufficient to provide an acceptable result, in most cases. The material left from previous repointing efforts presented the major difficulty. Soiling and biological growth was removed through an application of GranQuartz 515C Periodic Intensive Cleaner.

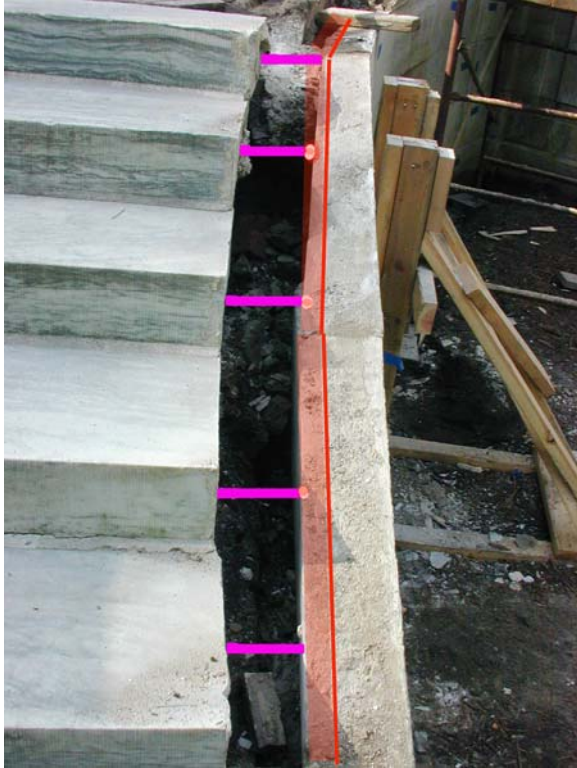
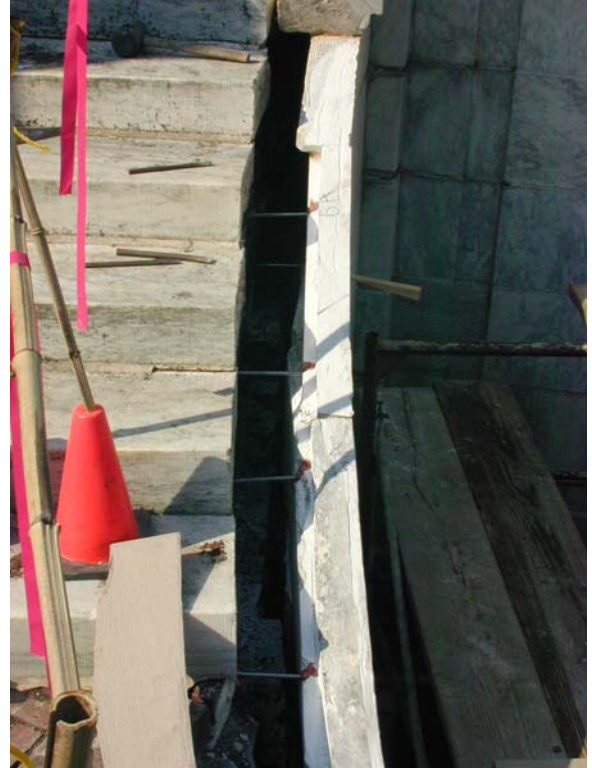
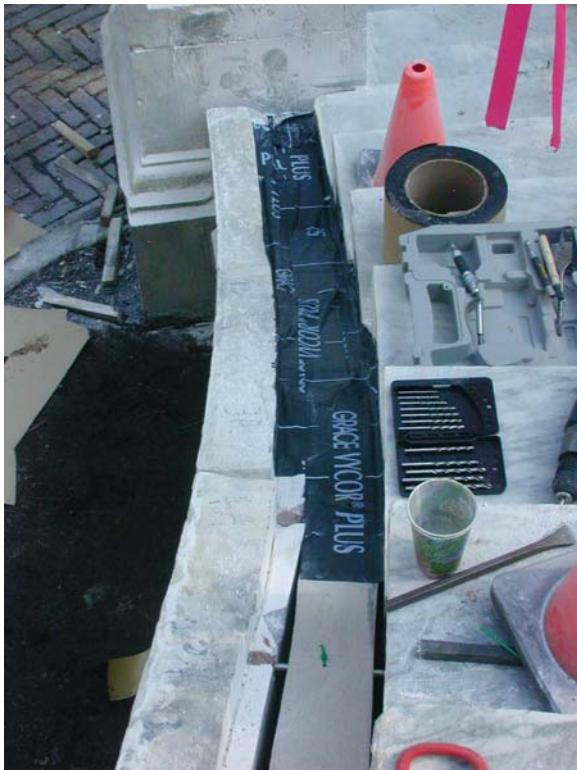
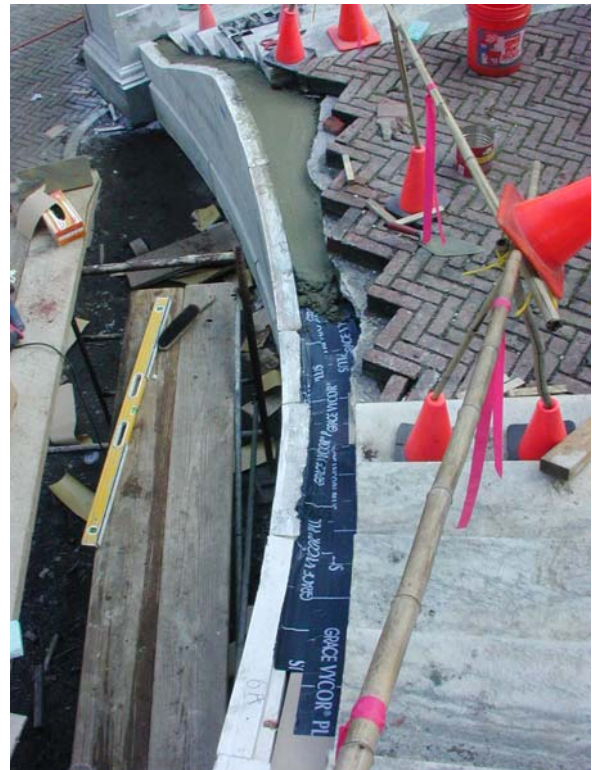
At this point we make our only major departure from the original design. As stated earlier, when dismantling the structure we discovered a cavity filled with soil and masonry debris. The copingstones are considerably wider than the façade blocks and in most places had less than a 50% bearing on the lower construction. It is very possible that the original masons purposely added this fill hoping to support the coping while the mortars set. If so the concept worked, initially. However, such a fill would hold moisture and in a freeze would exert an expansive force sufficient to displace the façade blocks. A slight movement would open the joints between the façade and the risers. In a thaw, the fill would soften and settle into the additional space left by the movement during freeze/expansion. Later rains would wash additional sediments into the open joints caused by the initial movement, beginning a cycle that could very likely have caused the eventual condition of near collapse. The fact that almost none of the intended anchors were installed certainly contributed to this progression. In order to cope with the situation, the following innovation was incorporated into the structure.

Hoping to keep the cavity open, facilitating drainage and aeration, it was decided to span the void between the top façade stone and the riser core structure with a concrete deck. Distributing the burden of the upper structures evenly amongst the separate lower constructs, provided a sound base for the copingstones without creating stresses that would encourage lateral movement. At left find the final detail for the concept.

The photos below show projected and actual implementation.

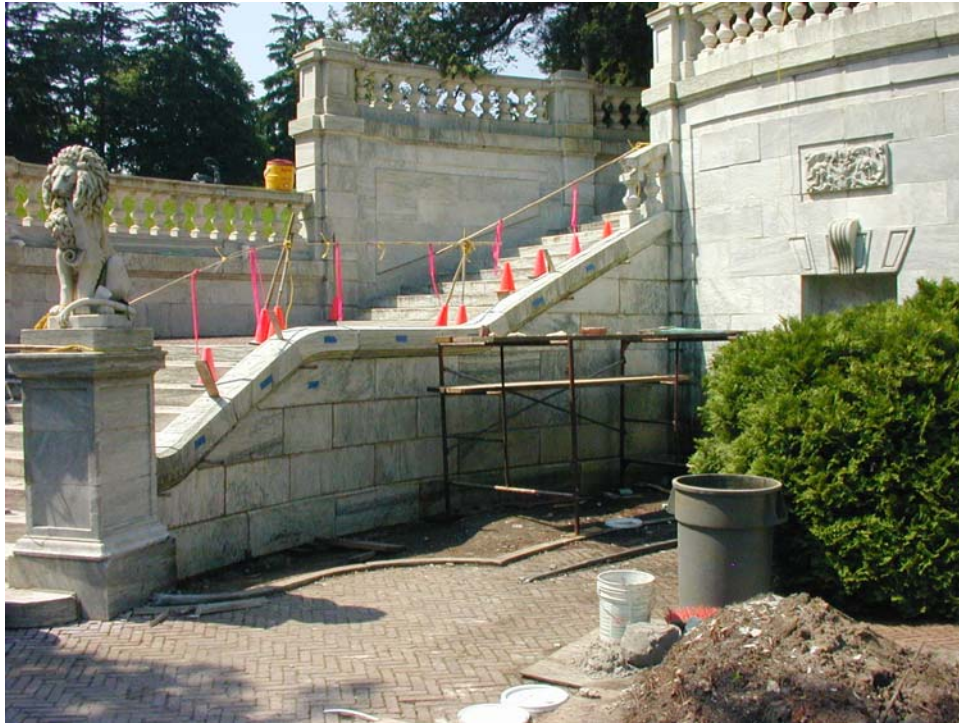
With setting of the copingstones the base structure was complete and we moved on to preparation of the balusters and rail. As can be seen at right, the material used to set the balusters was of an extremely tenacious bond. So much so that in dismantling, often the marble gave before the mortar. Before reassembly, the bonding surface of the stones had to be cleansed

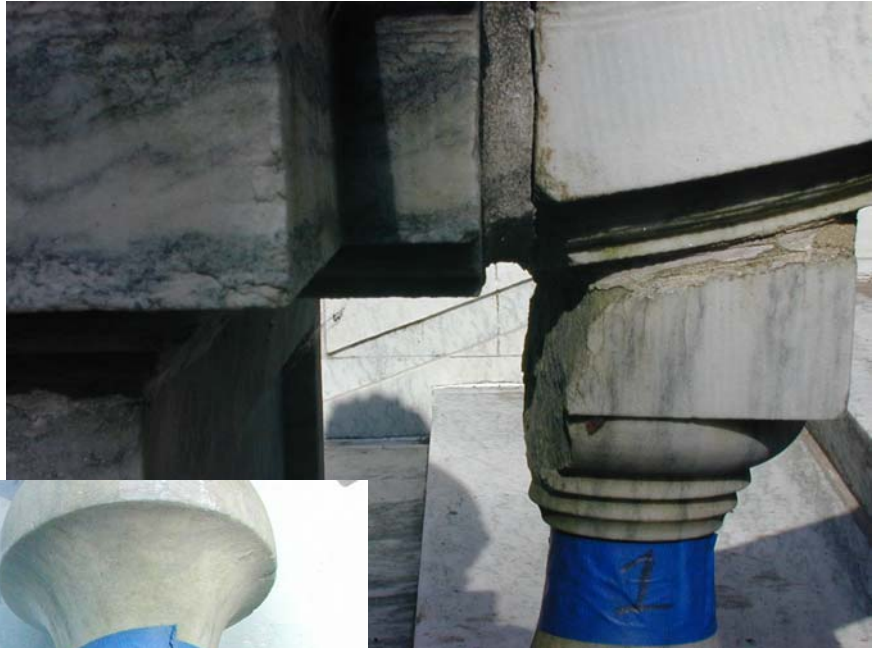
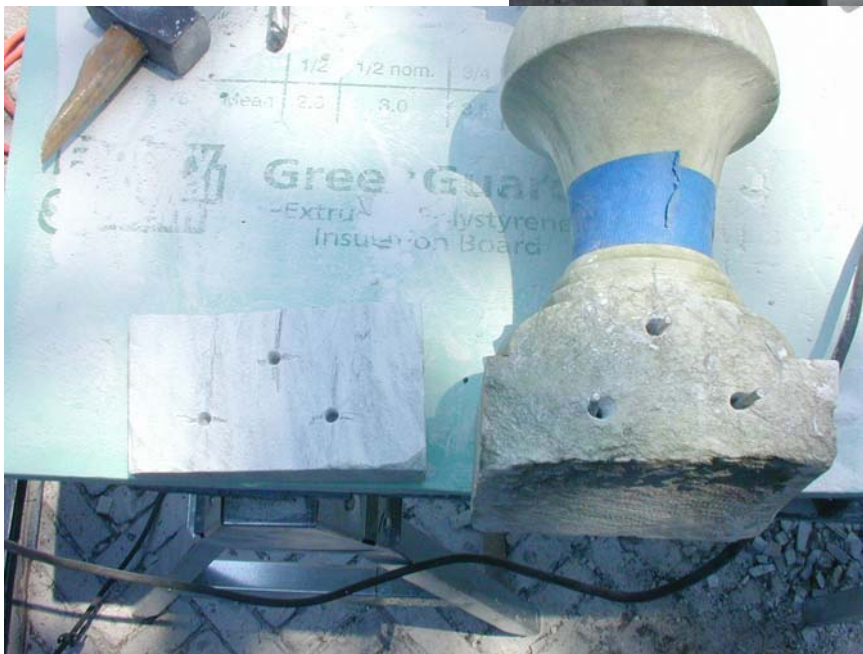
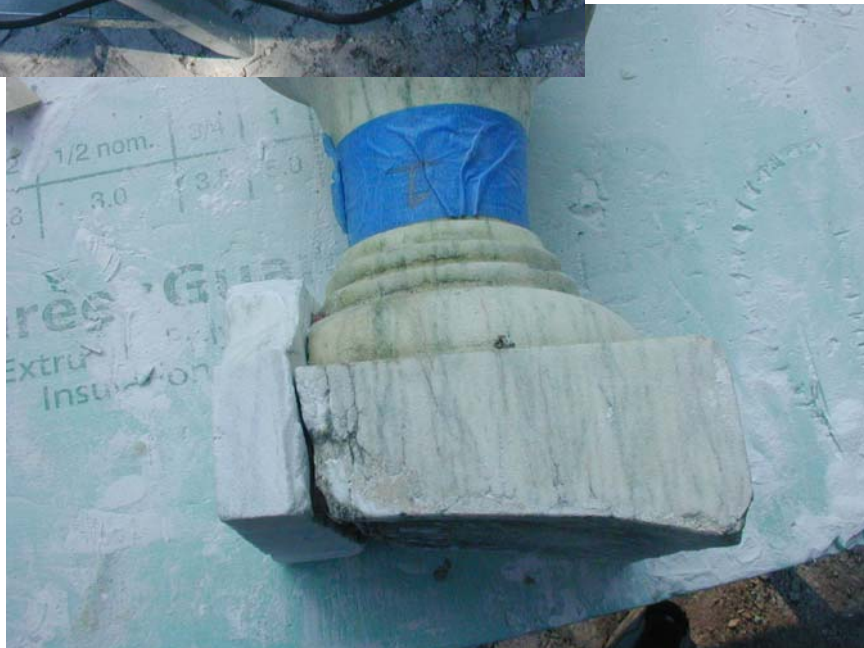
The photo at right shows the condition of the #1 baluster as we approached the job. Broken sometime in the past, the shards are unavailable, and replacements must be fabricated.

As documented in the previous operation, the stones are marked and drilled to accept stainless pins, that are anchored in Hilti epoxy, and left to cure overnight.

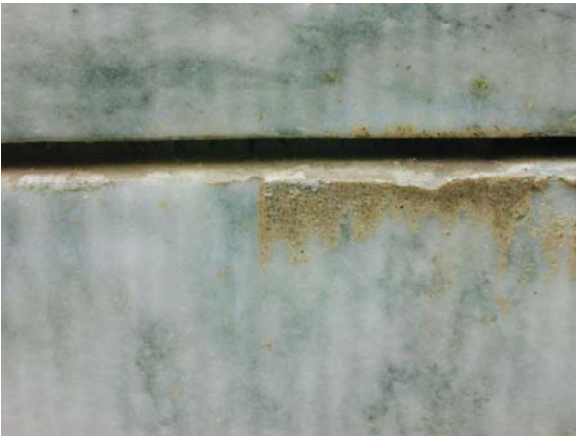
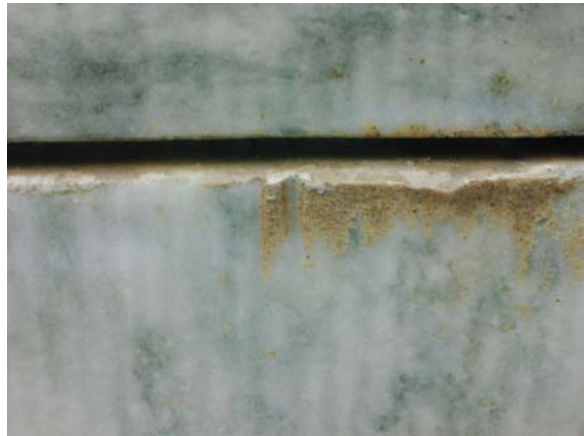
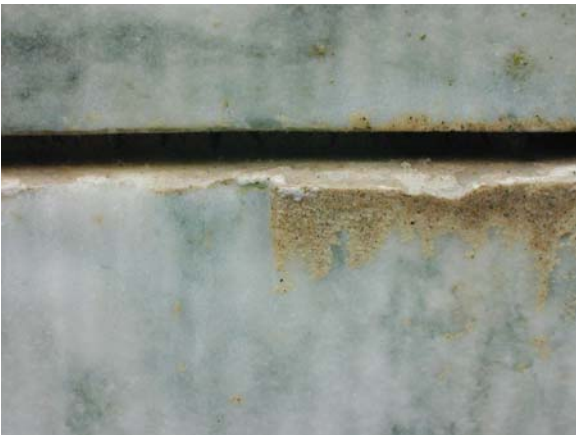
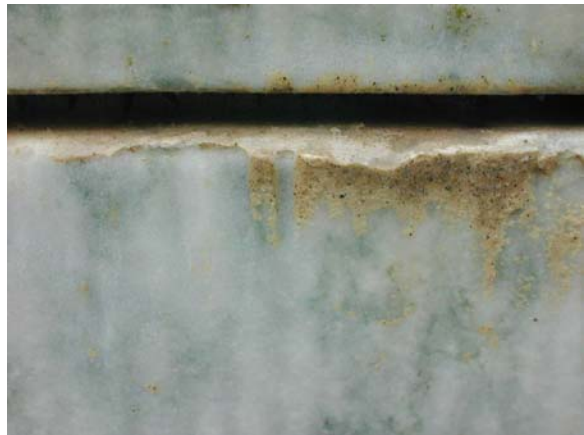
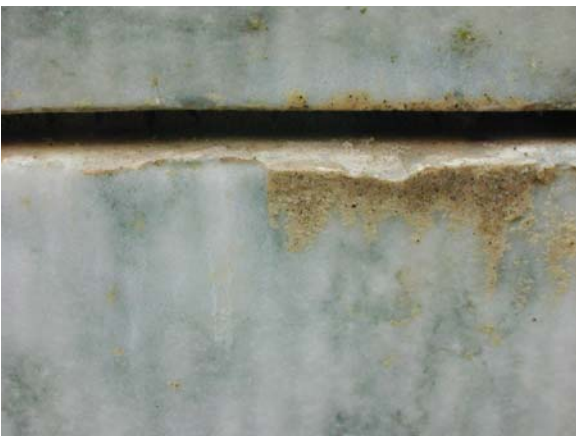
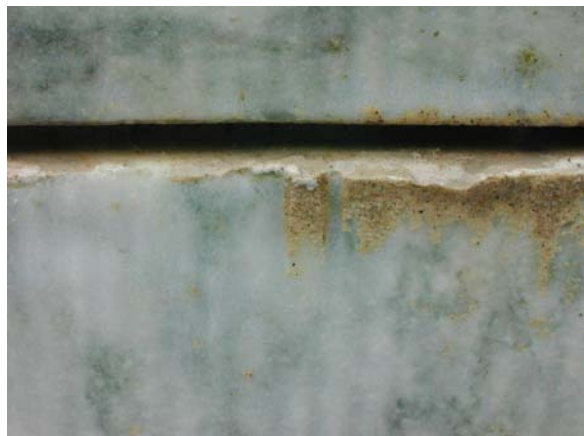
As mentioned earlier, previous repointing attempts had left a residue of hard Portland mortar, following the joints, and smeared across the face of the blocks. Because of the grooved texture applied as a finish to the stone neither hammer/chisel, nor grinder/sanders could be used to remove the material. As noted, a Dremel with shaped, heatless, ceramic wheels was used to carve away these unsightly deposits.

1) As one moves across the stone...

2) ...first carve the valley ...

3) ...then go back and clear the crest...

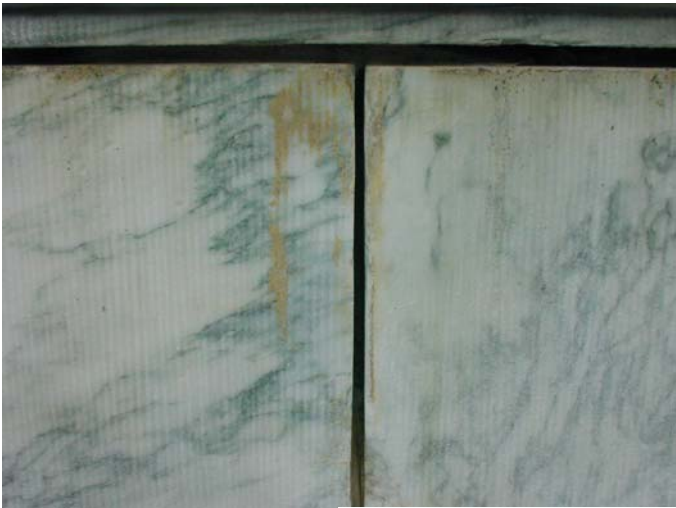
...and this...

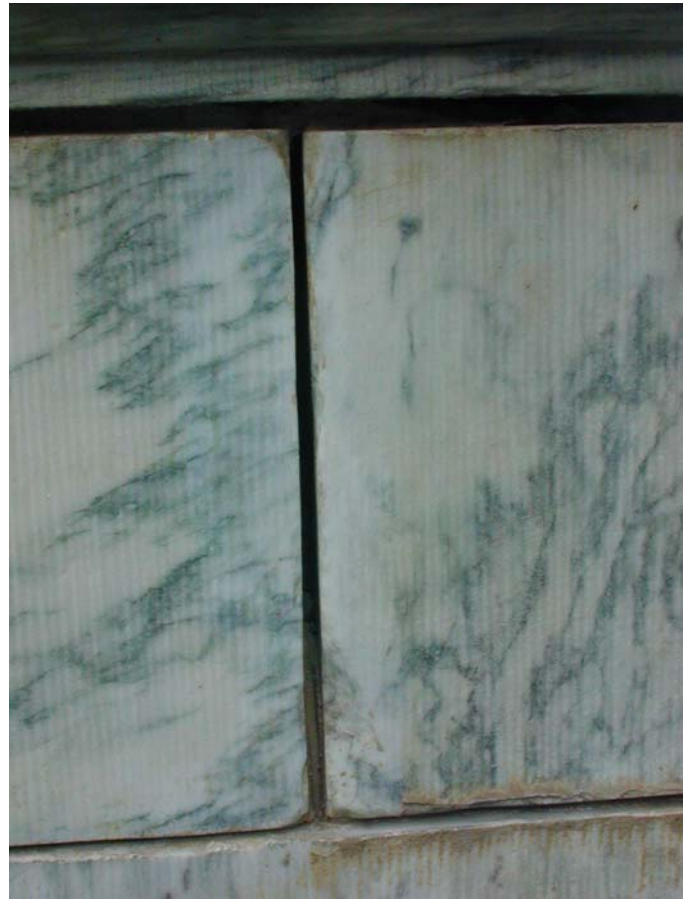
...just so...

Seven days were spent in this way, until all but those areas to be covered by plantings were clean. The carved areas were then lightly sand blasted to create a texture that would blend with the weathered fields adjacent.
